Technical Note 845-TN Fusion Appearance of Molded Fittings

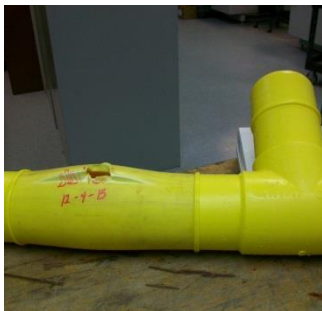
Figure 2 Burst Test

The quick burst test assesses the short term strength of the part. It was performed without a pipe fusion to show the strength of the fitting. The test was also performed fused to a pipe to show that the joint strength is stronger than that of the pipe or fitting.

Test	Standard	Test Result	Requirement	Result
Quick burst - Fitting Only	ASTM D1599 and 49 CFR 192.283	Burst at 760psi in 68 seconds	Minimum Burst of 552psi in 60-70 seconds	Pass
Quick burst – Fitting fused to pipe	ASTM D1599 and 49 CFR 192.283	Burst at 697psi in 67 seconds outside of knit line	Minimum Burst of 552psi in 60-70 seconds	Pass

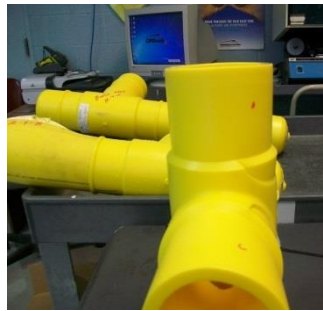
Figure 3 Crush Test

The crush test involved flattening the fitting in a press with the knit line located in the 'ears' of the flattened fitting. The test is a stringent measure of the strength of the knit line.

Test	Standard	Test Result	Requirement	Result
Crush Test	ASTM D3261	No cracking, crazing or separation.	No cracking, crazing or separation when the fitting is pressed flat with the knit line in the outer edge of the squeeze	Pass

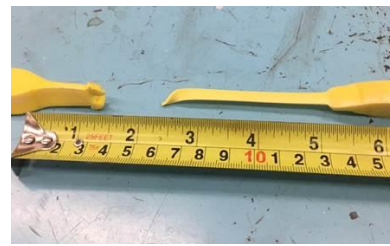
Figure 5 Tensile Test

the tensile test assesses the short term strength as measure by the tensile at yield. It also assesses the ductility of the pipe and fusion joint.

Test	Standard	Test Result	Requirement	Result
Elongation of Tensile at Yield	ASTM D638 and 49 CFR 192.283	Tensile at Yield exceeded 350% and failure occurred adjacent to and outside of the fusion zone.	Must exceed 25% and fail outside of the fusion zone.	Pass
